10.6.4. Replacing IGCTs

The second secon				
PRODUCT	DOCUMENT KIND	DOCUMENT ID.	REV.	LANG.	PAGE	
PCS6000	Service manual	3BHS600000 E80	FLY	en	149/272

+86 180301 10.6.5. Replacing power diodes

10.6.6. Checking stacks alignment

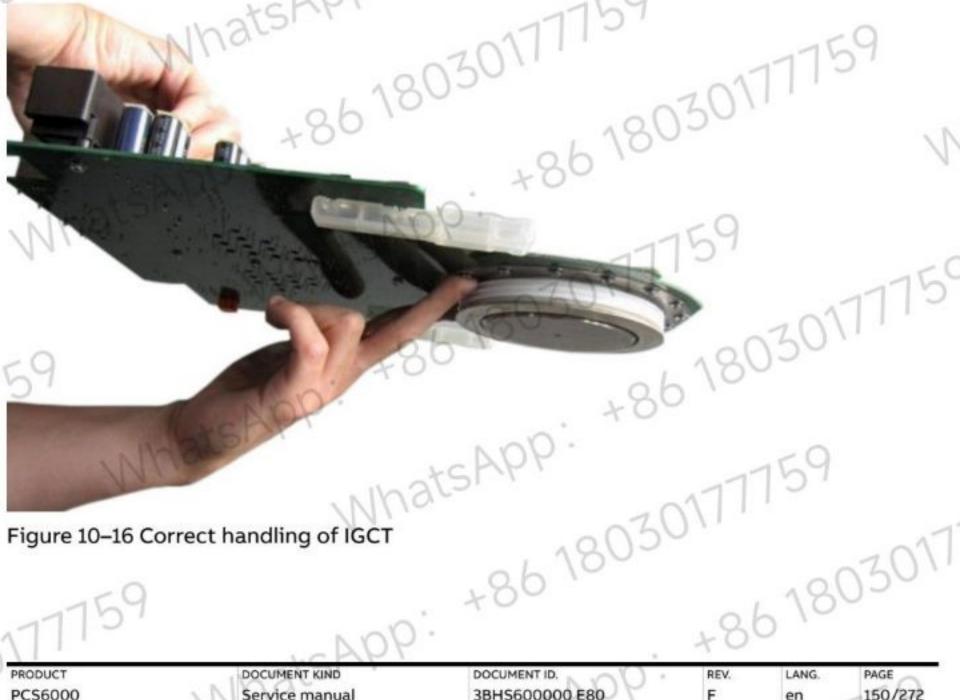
Figure 10-16 Correct handling of IGCT

NOTICE Hold the IGCT at the black plastic frame and support from underneath as shown in Fig. 10-16. Avoid touching the gate drive board or semiconductor.

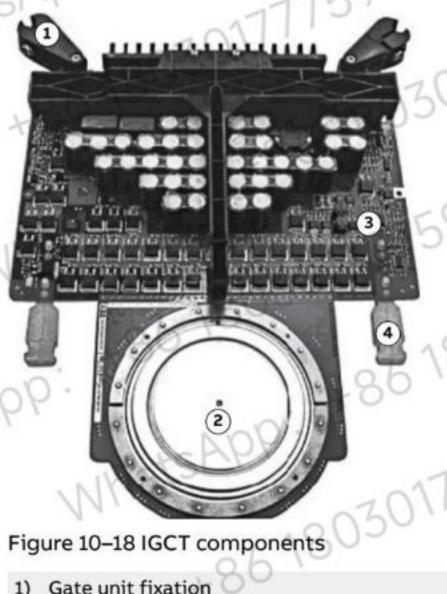
+86 180501111 7. In case the new IGCT is not fitted with positioning and stop devices remove them from the faulty IGCT and use them on the new one (see Fig. 10-18). WhatsApp: +8618

- 1) Gate unit fixation
- Semiconductor

- Gate drive
- 4) Positioning and stop device
- 8. Clean the contact surfaces of the IGCT with a fluff-free cloth.
 - Clean heavily polluted surfaces with a cleansing agent (eg, pure alcohol). The surfaces must be free from dust, fat and oil.

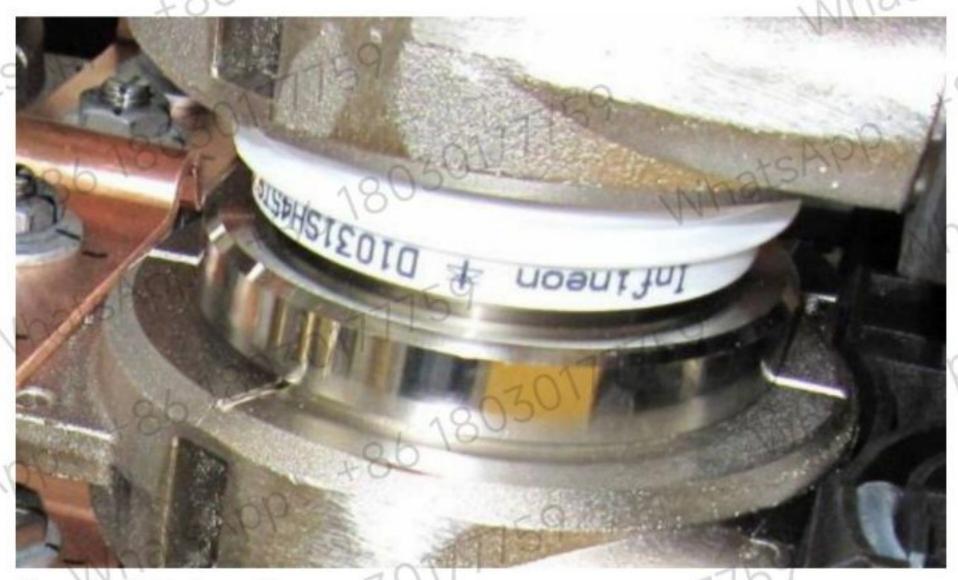
Figure 10-20 Diode marking

+86 1803017 6. Rotate the diode so that you can easily see the serial number (see Fig. 10-20).

- 4) Centering ball
- 5) Upper centering ball
- 6) Lower centering ball
- 7. Rotate the diode so that you can easily see the serial number (see Fig. 10-20).
- 8. Remove the spreading tool.
- 9. Remove the stabilizer plate.
- Check the stack alignment according to section 10.6.6, Checking stacks alignment, page 159.
- 11. Tighten the stacks according to section 10.6.7, Tightening the stacks, page 166.
- 12. Re-check the diodes according to section 9.9.3, Checking clamp diodes, page 130.
- Restart the PCS6000 according to section 5.4, Start-up after maintenance or troubleshooting, page 70.

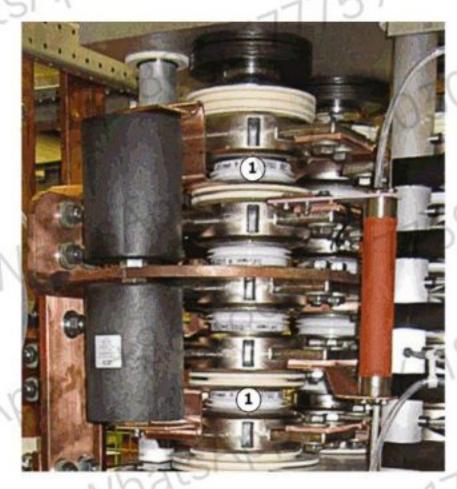
Figure 10-21 Clamp diodes

The position of the clamp diodes is at the top and bottom of each phase stack (see Fig. 10-WhatsApp: +8618

1) Clamp diode

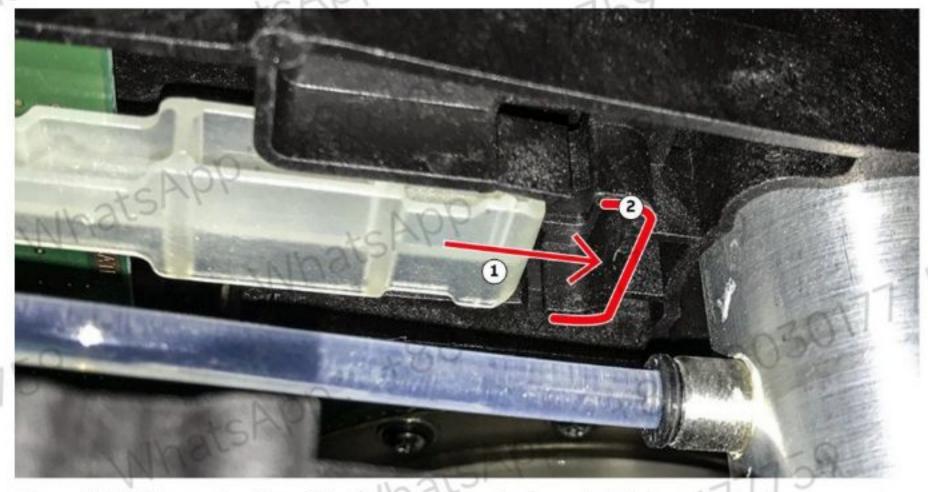
Figure 10-25 Example of positioning and stop device not fully inserted yet

An IGCT stack is aligned when all IGCTs have been correctly inserted, ie, the positioning and stop device (1) of each IGCT has been fully inserted into the guiding rails (2).

1) Positioning and stop device

2) Guiding rails

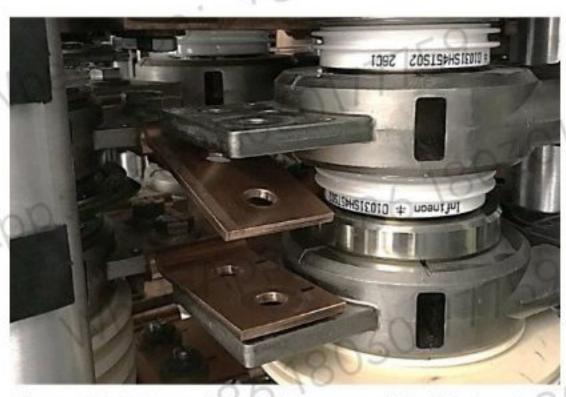
Figure 10-27 Heat sink with loosened flexible bus bar.

1. On the misaligned heat sinks, loosen the flexible busbar on the heat sink side by removing the M12 bolts with two 19 mm wrenches.

IMPORTANT! Carefully note the direction of bolts assembly, which is not always the same on each heat sink. If you drop a washer, bolt or nut into the power module or cubicle, remove it immediately.

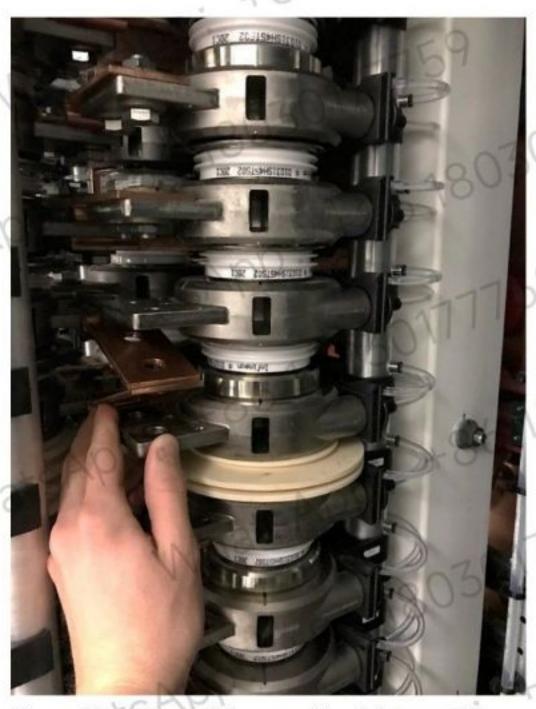
Figure 10-29 Heat sink moved back into position.

4. From bottom to top, gently move each misaligned heat sink back into position by hand.

NOTE – If you cannot move the best sink NOTE - If you cannot move the heat sink, use the spreader tool to spread open the heat sinks above and below the heat sink and then try again.

NOTICE Applying too much force when you move the heat sink can scratch the semiconductor surface.

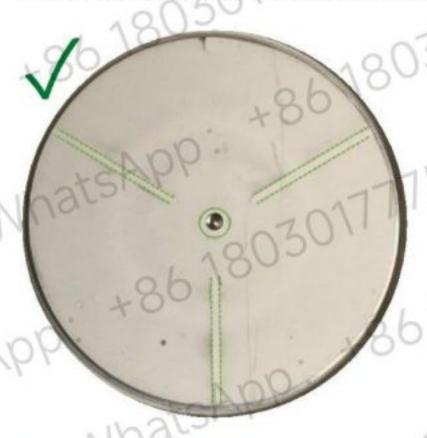
- Observation: All imprints of the above heat sink are centered on the pole piece of the semiconductor.
- Heat sink and semiconductors are well aligned. WhatsApp: +8

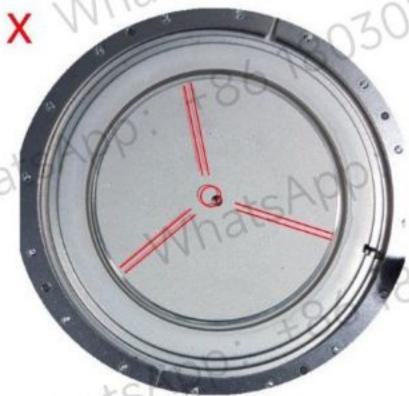
- Observation: Imprints from above heat sink are not centered on the IGCT pole piece.
- Possible cause: IGCT not fully inserted before the stack was tighten.

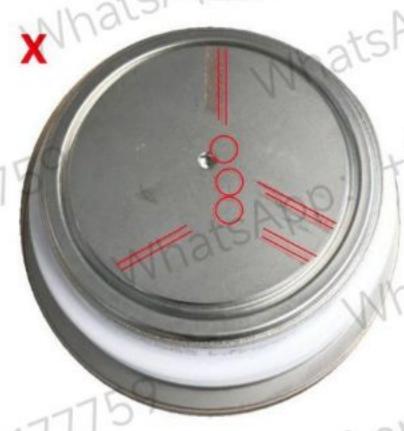
- : +86 18030177759 Observation: Several imprints from above heat sink are not centered on the pole piece.
 - Possible cause: Severe and repetitive misalignment of the above heat sink or missing centering ball.

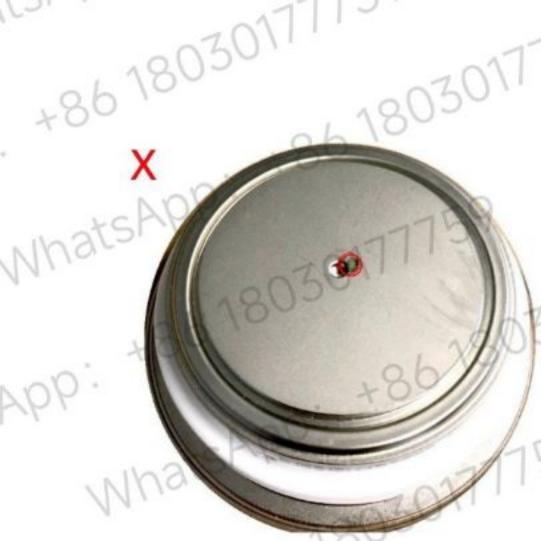
- Observation: Imprint of centering ball on the diode pole piece.
- centering ball before stack tightening. WhatsApp:

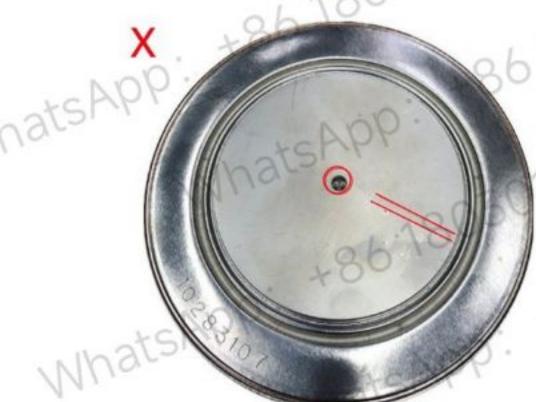
- Observation: Missing imprints from the heat sink on the semiconductor pole piece or non-homogeneous imprints to the touch
- Possible cause: Semiconductor tighten inside an already misaligned stack WhatsAPP (pressure distribution not nominal).

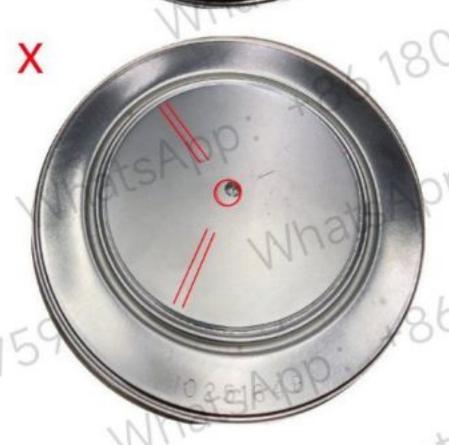
- Observation: Missing imprints from the heat sink on the semiconductor pole piece or non-homogeneous imprints to the touch
- Possible cause: Semiconductor tighten inside an already misaligned stack (pressure distribution not nominal). PP: +86 18030177

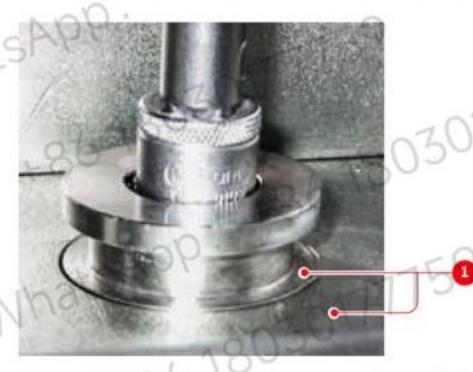
Figure 10-32 Adjusting clamp pressure of stack

+86 18050111 2. Tighten the clamping screw until the pressure loading gauge is just released and the surfaces are even, then remove the pressure loading gauge (see Fig. 10-32). WhatsApp: +86 18

- 1) These surfaces must be even
- 3. Fasten the pressure loading gauges in their storage place with the M12 fastening screw and washer using a 19 mm wrench.

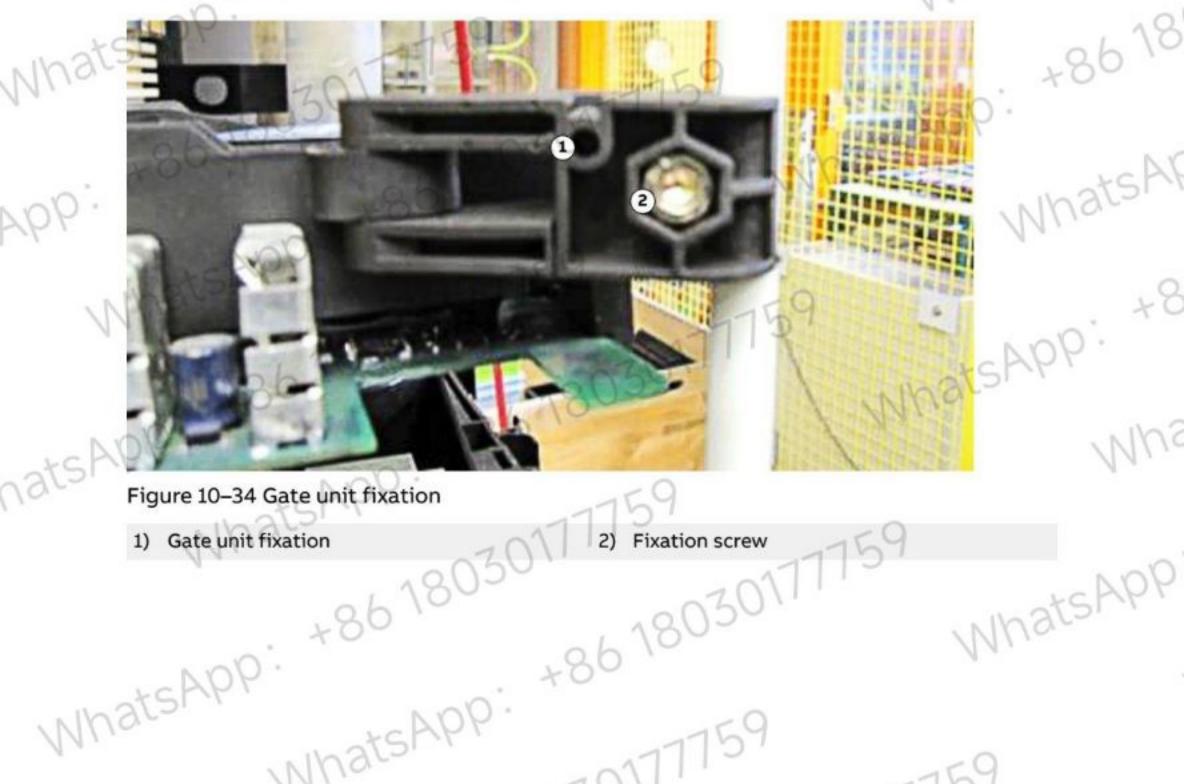
+86 180501111 4. Tighten the 24 fixation screws of the IGCT gate unit fixations using a 5 mm Allen wrench.

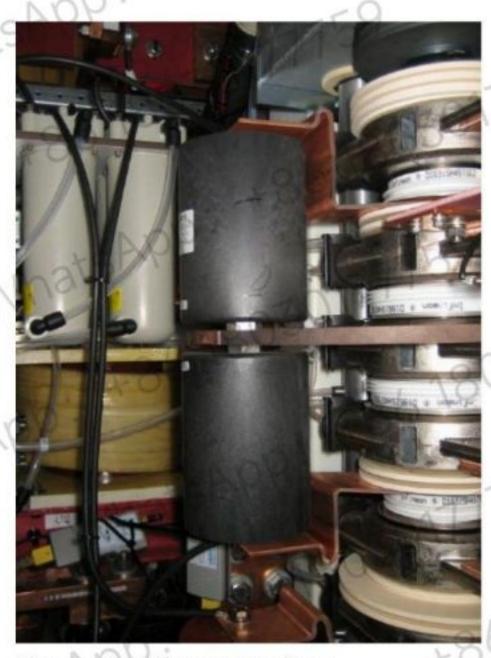
Figure 10-35 Clamp capacitors

1. Unbolt the upper and lower copper bar from the capacitor.

NOTICE DO NOT exert any torque onto the capacitors. During loosening as well as fastening, the capacitor connections need to be held in place with a 23 mm flat wrench Whats (contained in converter service toolbox).

2. Use flat wrench from ABB toolbox to access the capacitor nut and loosen the capacitor(s).
